Technical Report CHL-97-17
August 1997

Periodic Inspection of Humboldt Bay Jetties, Eureka, California

Report 1 Base Conditions

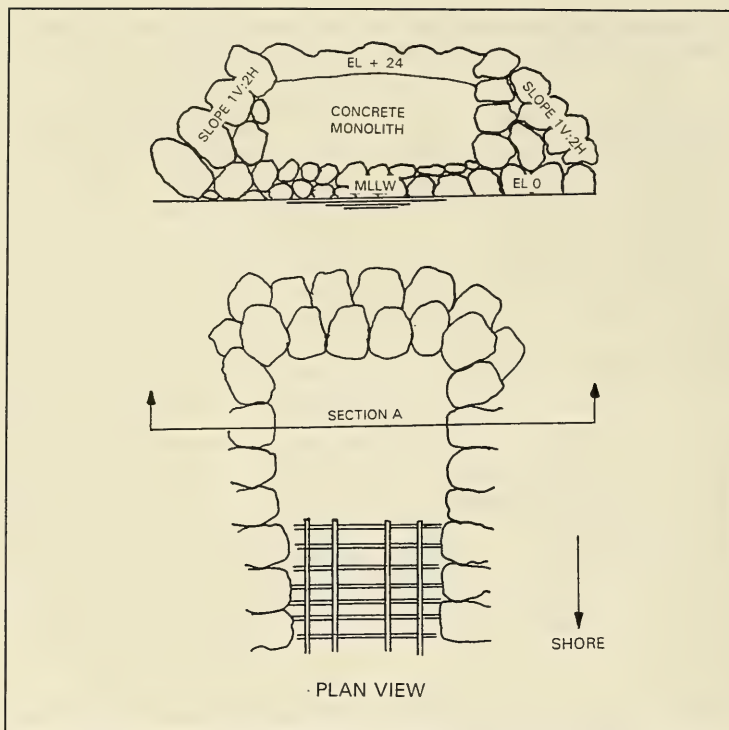
The head of the south jetty, which had been subjected to some of the most severe damage, was reinforced with a concrete monolith that was 9.1 m (30 ft) wide and 4.3 m (14 ft) deep (Figure 2). The 861,825-kg (950-ton) monolith was placed in the center of the head and armor stones up to 18,140 kg (20 tons) were laid up adjacent to the monolith. The el of the head was raised to +7.3 m (+24 ft) and the voids between the armor stones were filled with stones of not less than 227 kg (500 lb) in weight.

Figure 2. Concrete monolith structure constructed on south jetty in 1911

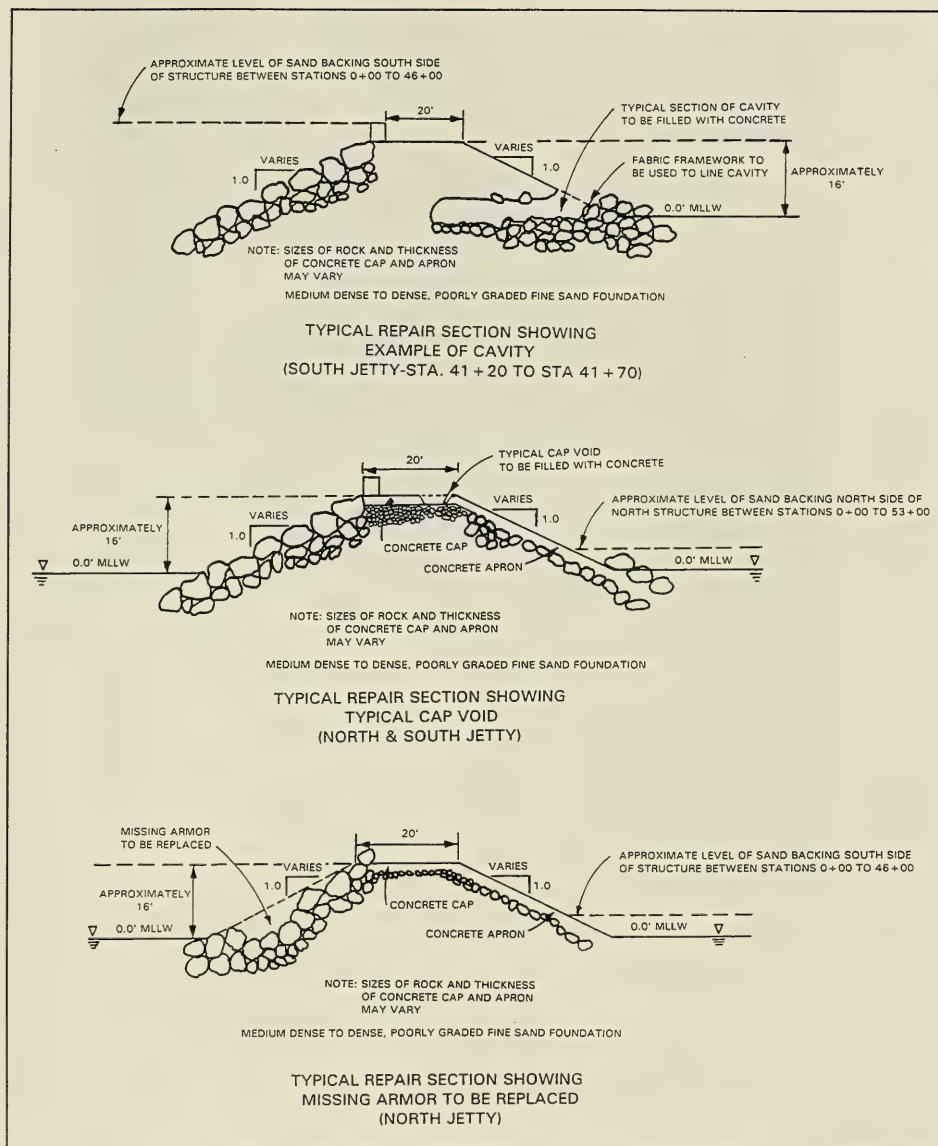
Figure 5. Typical repairs made to jetties in 1988

In 1988, substantial repair work was done on both of the jetties. Repairs involved the use of approximately 181,440 kg (2,000 tons) of stone for slope repair and 765 cu m (91,000 cu yd) of concrete for the filling of voids in the structure (USAED, San Francisco 1988). Figure 5 shows typical repairs made in 1988, and Figure 6 provides a plan view of Humboldt Bay, the jetty structures, and the navigation channels as of December 1994.

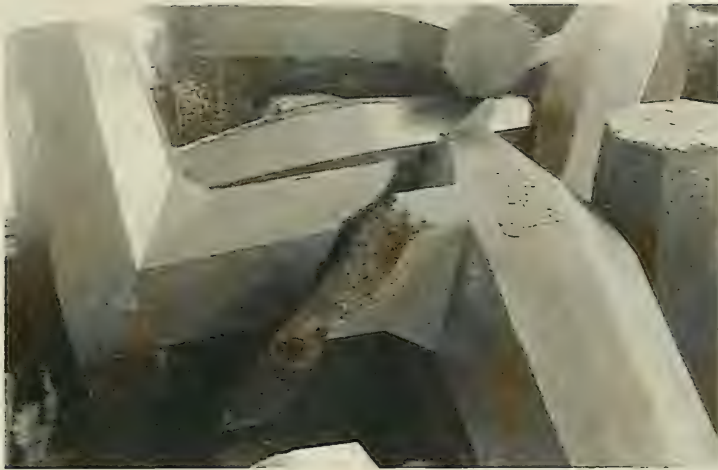
approximate center line of the structure. At the heads of the structures the baselines were projected seaward along the axis of the jetties. Thirty-four broken or cracked dolosse (seventeen on each jetty) were identified during the walking survey. Armor units with hairline cracks on one side were not counted; only those that were cracked all the way through were considered a break for recording purposes. Breaks were categorized as occurring in the shank or the fluke and as straight across or at some angle to the dolos limb. The shank is the central beam of a dolos, and the flukes are the beams on the ends of the armor unit. The broken units on the north jetty consisted of seven mid-shank breaks, eight shank-fluke breaks (shank broken in vicinity of fluke), and five fluke-shank breaks (fluke broken in vicinity of shank). One unit had two breaks. Breaks on the south jetty were characterized as follows: two units, mid-shank breaks; eight units, shank-fluke breaks; and seven units, fluke-shank breaks. Of the 35 breaks, 27 were straight breaks and 8 were angled breaks (approximately 45 deg or greater). Representative broken dolosse are shown in Figures 17-20.

Figure 17. Dolos with angled, mid-shank break

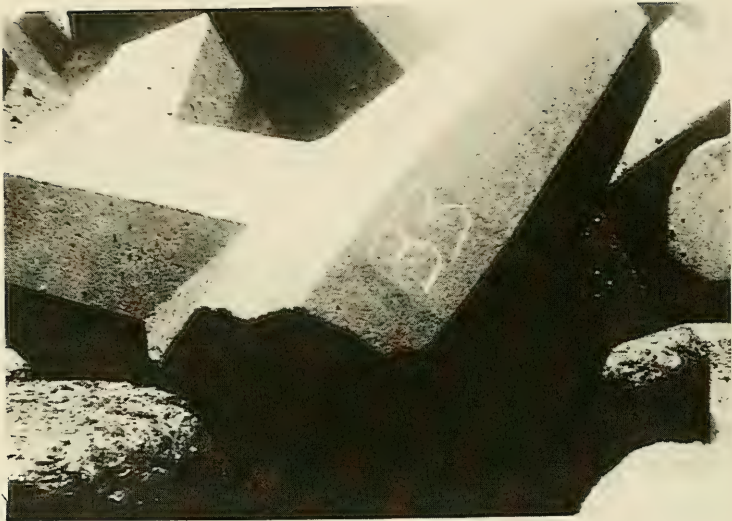
Figure 19. Dolos with straight fluke-shank break

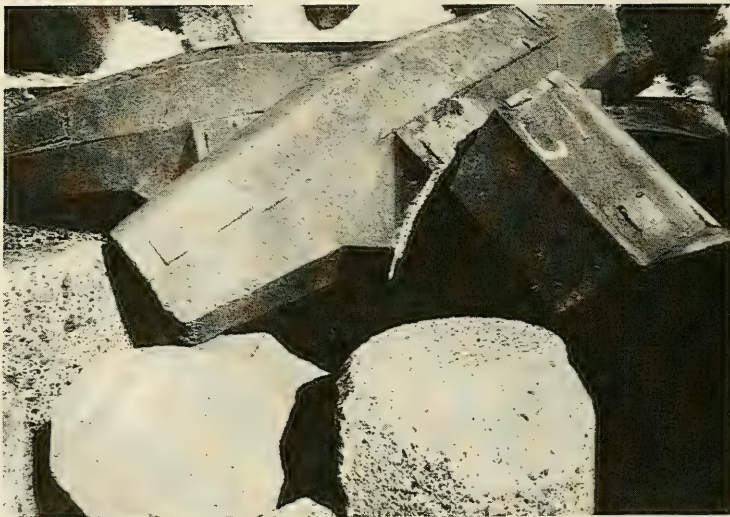
Figure 20. Dolos with straight, shank-fluke break

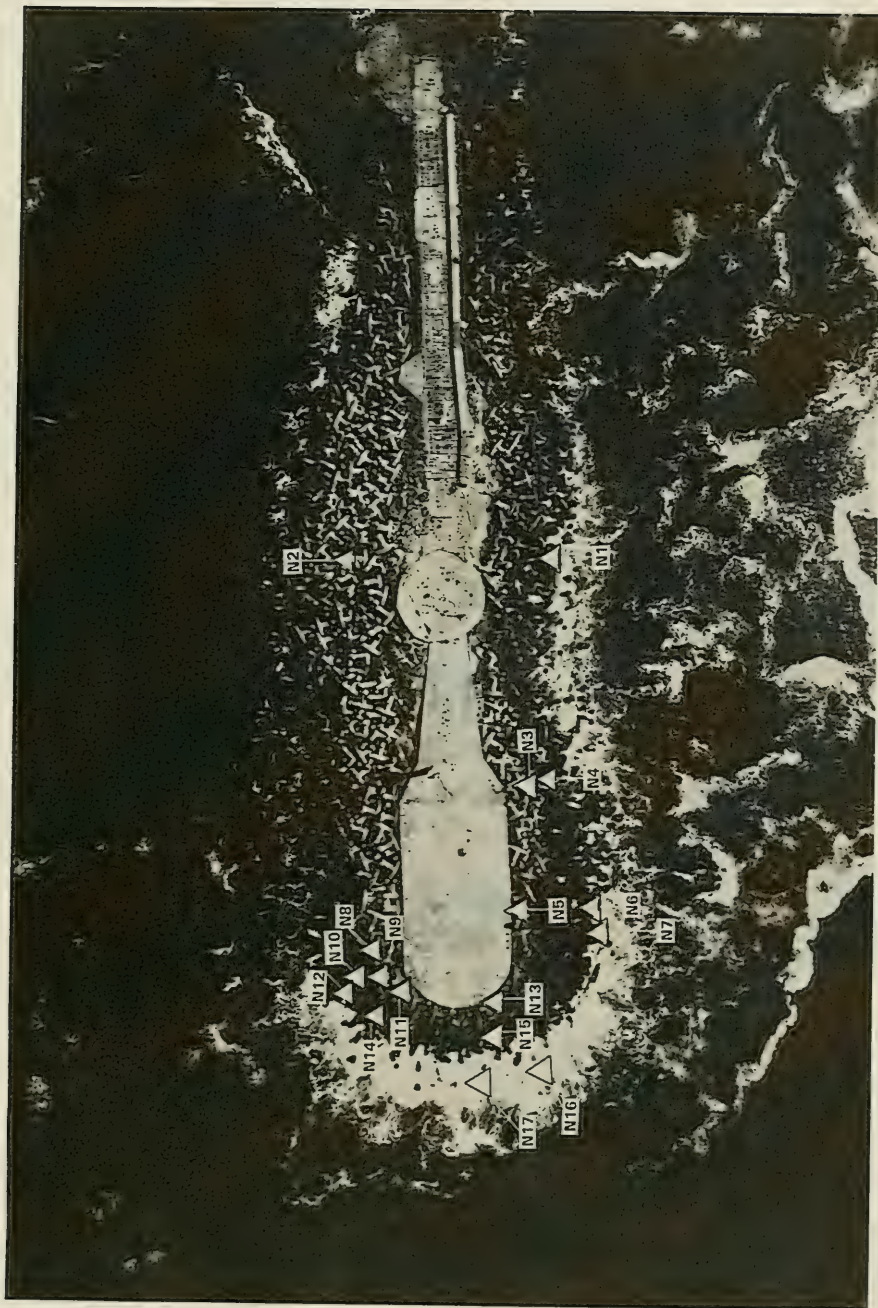
Approximate locations of the broken/cracked dolos armor units are shown in Figures 21 and 22, respectively, for the north and south jetties; and detailed data obtained during the broken armor unit inventory are shown in Table 4. Armor unit numbers identified in Figures 21 and 22 correspond to those listed in Table 4. As shown on the figures, broken units are concentrated along the seaward ends of the jetties. Eighty-eight percent of the broken units on the north jetty and seventy-one percent of those on the south jetty are located around the monolithic structures at the jetty heads. In addition, more broken dolosse were observed on the south sides of the structures than on the north. If the approximate center lines of the jetties are projected seaward along the axes of the structures, 59 percent of the broken units on the north jetty and 65 percent of those on the south jetty are located on the southern side of the jetties. With regard to distance downslope from the jetty caps, most the broken dolosse appear to be located in the active wave zone. Detailed data obtained during the broken armor unit survey will allow for an accurate indication of new breaks when the structure is revisited at some point in the future.

Figure 21. Approximate locations of broken/cracked dolos armor units on the north jetty

Armor Unit No.	Station No.	Offset from Baseline m (ft)		Type of Break, Comments
		Seaside	Channelside	
N1	71 + 17		25.30 (83)	Straight mid-shank break
N2	71 + 17	22.86 (75)		Straight mid-shank break
N3	72 + 90		18.29 (60)	Straight shank-fluke crack
N4	72 + 90		21.95 (72)	Straight mid-shank break
N5	73 + 82		14.63 (48)	Straight shank-fluke break
N6	73 + 82		32.00 (105)	Straight mid-shank break
N7	74 + 00		33.53 (110)	Angled mid-shank break
N8	74 + 10	18.29 (60)		Straight shank-fluke break
N9	74 + 30	16.76 (55)		Straight fluke-shank break
N10	74 + 30	21.34 (70)		Straight shank-fluke break
N11	74 + 40	12.19 (40)		Straight mid-shank break
N12	74 + 40	24.38 (80)		Straight fluke-shank break Angled mid-shank break
N13	74 + 55		15.24 (50)	Straight fluke-shank break
N14	74 + 65	18.29 (60)		Angled shank-fluke crack
N15	74 + 85		9.14 (30)	Straight fluke-shank break
N16	75 + 05		20.12 (66)	Straight fluke-shank break
N17	75 + 10		2.05 (10)	Straight mid-shank break

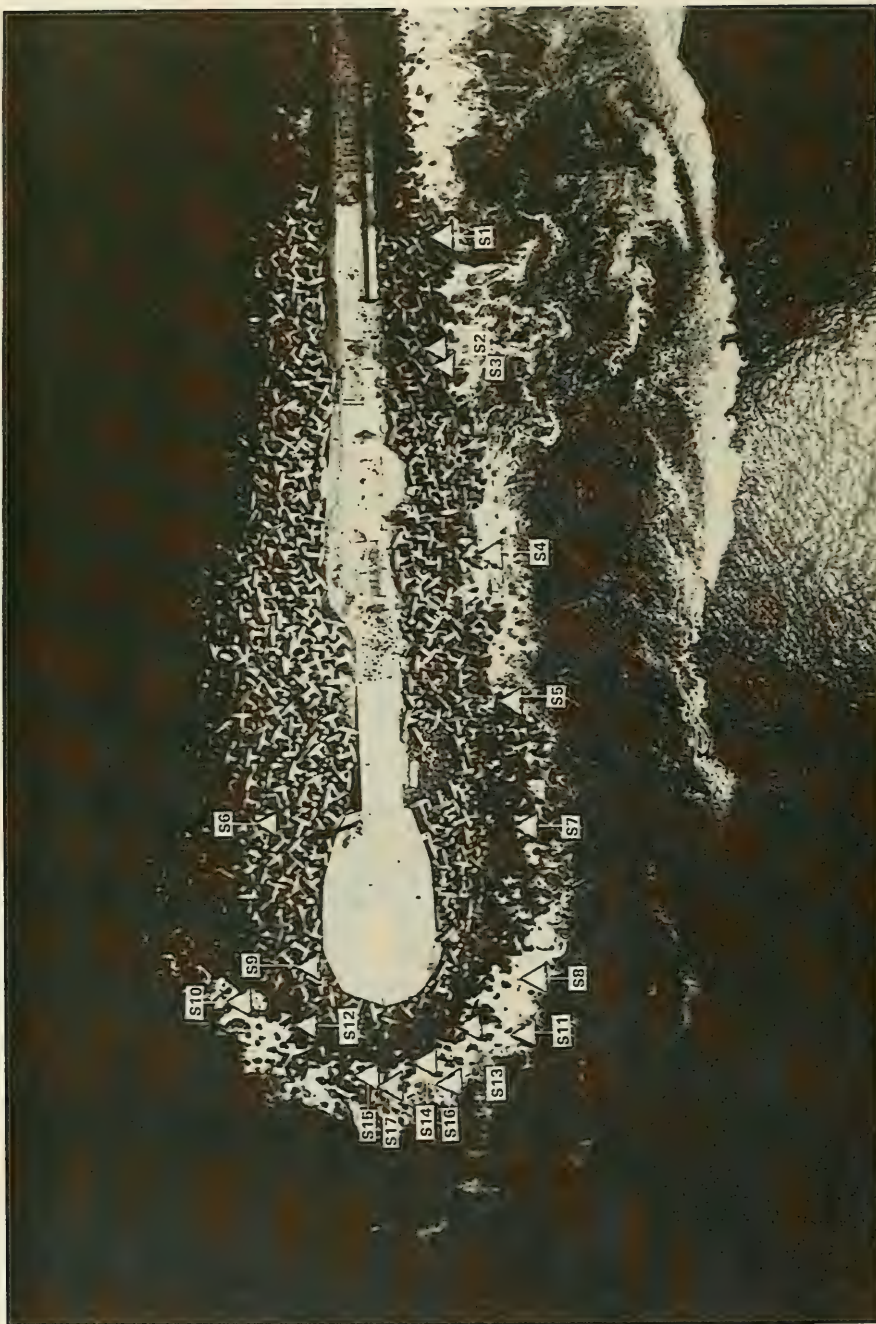
Figure 22. Approximate locations of broken/cracked dolos armor units on the south jetty

S1	84 + 59	21.95 (72)		Straight shank-fluke break
S2	85 + 36	18.29 (60)		Angled shank-fluke break
S3	85 + 45	18.29 (60)		Angled fluke-shank crack
S4	86 + 85	29.26 (96)		Angled fluke-shank crack
S5	88 + 00	31.09 (102)		Straight shank-fluke break
S6	88 + 90		25.60 (84)	Straight fluke-shank break
S7	89 + 08	34.75 (114)		Straight shank-fluke break
S8	90 + 00	36.89 (120)		Straight fluke-shank break
S9	90 + 00		15.24 (50)	Angled shank-fluke break
S10	90 + 24		33.53 (110)	Angled mid-shank break
S11	90 + 44	31.70 (104)		Straight fluke-shank break
S12	90 + 46		18.29 (60)	Straight shank-fluke break
S13	90 + 50	19.81 (65)		Straight mid-shank break
S14	90 + 70	9.14 (30)		Straight shank-fluke break
S15	90 + 80		3.05 (10)	Straight fluke-shank break
S16	90 + 84	14.02 (46)		Straight fluke-shank break
S17	100 + 90		0.61 (2)	Angled shank-fluke break
